#### **SECTION IV – FACILITY DESIGN (STORAGE)**

## A. STORAGE AREAS FOR DRUMS / CONTAINERS / TANKS / OTHER DEVICES

**Secondary Containment Certification**

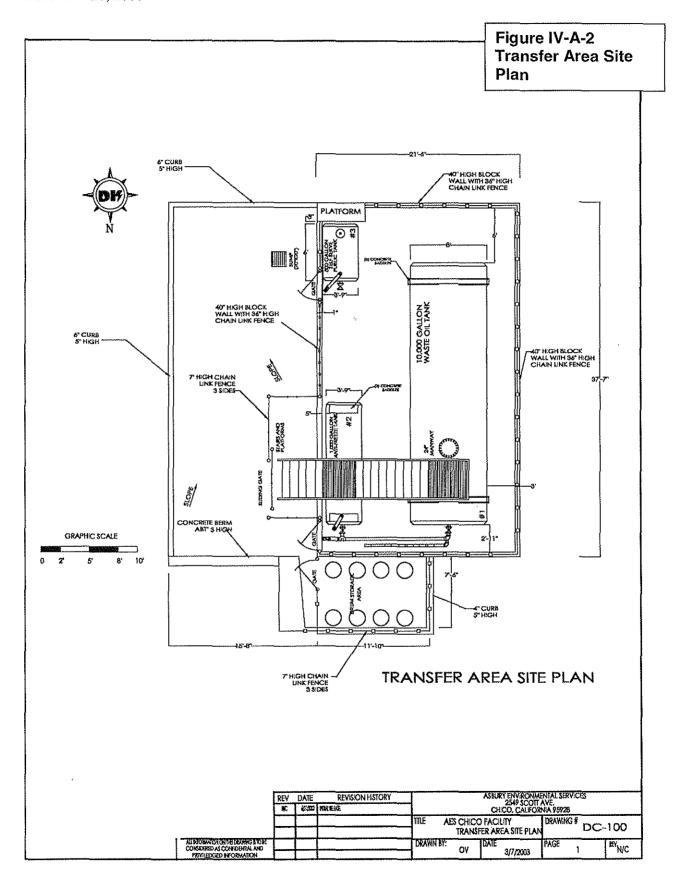
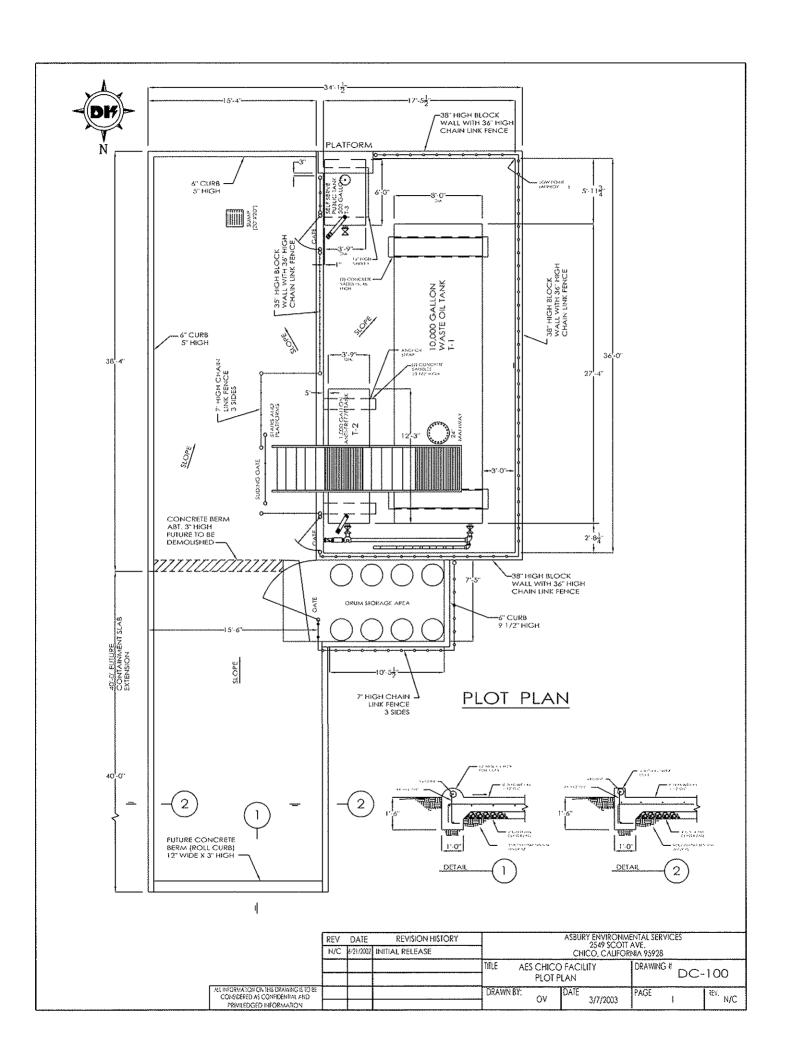
It was noted in Figure IV-A-2, Transfer Area Site Plan, that the truck containment slab will be extended an additional 40 feet as part of a future project. It was also noted that the existing truck containment slab has some cracking which needs to be repaired.
